# 石窟寺岩体劣化研究进展:机制、试验、数值模拟与防护

## Deterioration of grotto temple rock masses: A review of mechanisms, experimentations, modeling and conservation measures

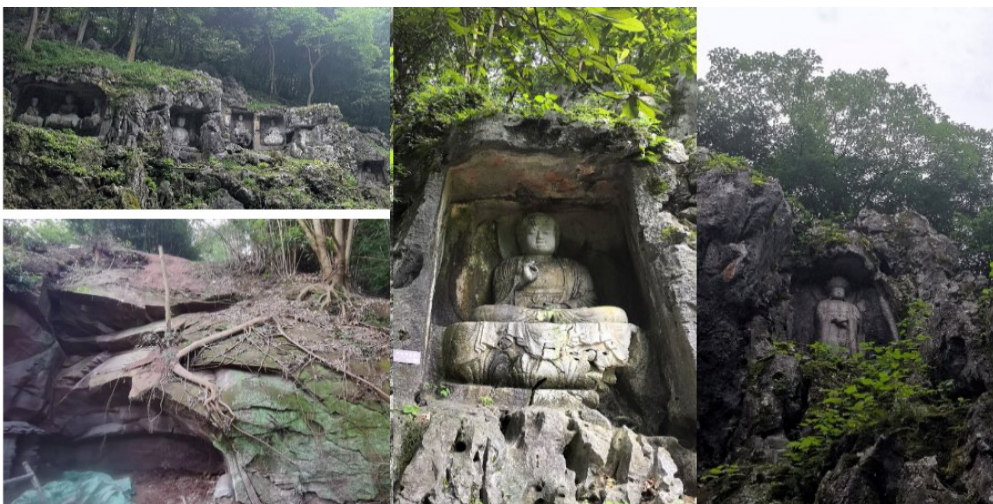
**Fig. 3 Primary structures that have a relatively great impact on rock mass deterioration**

Weak intercalated layers are characterized by low strength and high compressibility, rendering them vulnerable zones in a rock mass (Fig. 3(a)). Under internal and external forces, they tend to cause differential weathering in a rock mass and form rock cavities. Weak intercalated layers also significantly increase the heterogeneity and anisotropy of a rock mass, directly affecting the mechanical behavior and stability of the geological formation and causing its

Bedding planes are the surfaces between layers in sedimentary rocks, marking the boundaries between layers with different sedimentary components and sedimentary histories (Fig. 3(b)). These planes, which strongly affect the fracture behavior of layered rocks, have a strength normally lower than that of the rock matrix<sup>[43]</sup>. Research has shown that the existence of bedding planes enhances rock heterogeneity, resulting in differences in the strengths and elastic moduli of rocks oriented in different directions<sup>[44]</sup>. For instances, Meng et al.<sup>[45]</sup> conducted three-point bending tests on semicircular bending rock specimens and found that the angle of the bedding plane significantly affects the fracture toughness. With increasing bedding plane angle, the stress intensity factors for mode I (opening mode) and mode II (sliding mode), as well as the effective fracture toughness of the rock specimens, decrease. The existence of weak bedding planes can also help aqueous solutions to more smoothly penetrate a rock mass, accelerating the weathering of carbonate cement in the rock formation<sup>[46]</sup>.

When subjected to external forces, a rock mass typically deforms and fails along its structural planes first (Fig. 3(c)). Structural planes include joints, faults, and interlayer shear zones. Their existence destroys the continuity of a rock mass, thus affecting its stability and integrity and easily inducing rock mass failures, such as collapse, sliding, and falling

(a) Weak intercalated layers<sup>[50]</sup>

(b) bedding planes in a grotto cave<sup>[51]</sup>

(c) structural planes (source: Dazu Rock Carvings Research Institute)

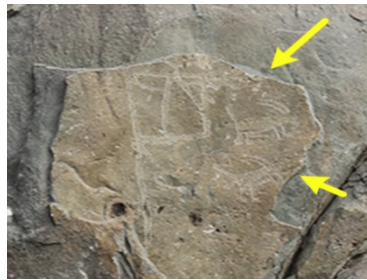
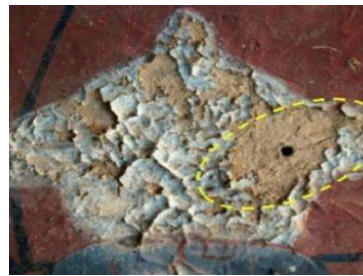
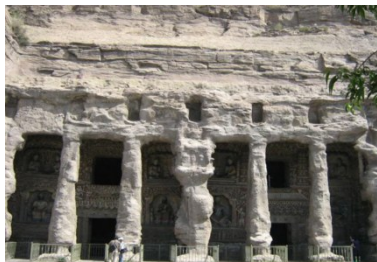
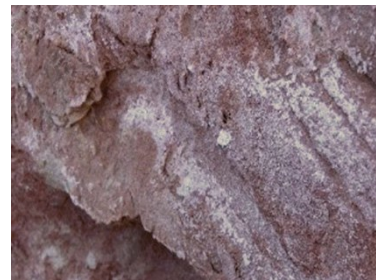
**Fig. 4 Causes of rock deterioration**

(a) A freeze-thaw cycle causes peeling in rock paintings<sup>[55]</sup>

(b) A wet-dry cycle leads to the peeling of mural paintings<sup>[56]</sup>

(c) Rock pillars exposed to the water-rock cycle<sup>[57]</sup>

(d) Salt crystallization weathering<sup>[58]</sup>

dry cycles, thermal-humid cycles, and salt crystallization weathering (Fig. 4), but the primary triggers of physical weathering are the first two processes.

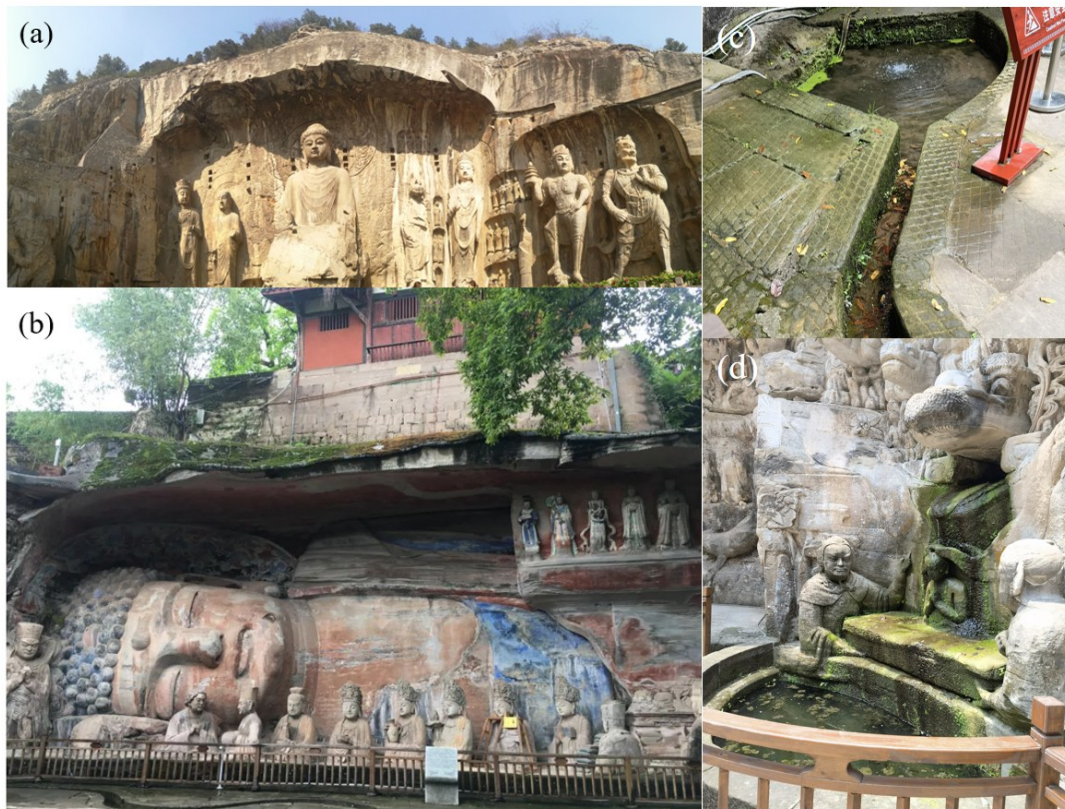
**Fig. 18 Grottoes with drainage measures taken**

Note: (a) The Lushena Grand Buddha at Fengxian Temple of the Longmen Grottoes, (b) the Reclining Buddha at Baoding Mountain of the Dazu Grottoes, (c) and (d) the drainage facilities of the Reclining Buddha on Baoding Mountain.

The grottoes shown in Fig. 18 are located in a

rainy area, and the drainage system effectively prevents water damage-induced instability in the grotto rock masses. Drainage measures for grottoes include surface and underground drainage. The former guides rainwater away from grotto rock masses through constructed intercepting ditches and drainage ditches, among other measures<sup>[153-154]</sup>. The latter uses configurations such as drainage holes and drainage galleries to decrease groundwater and reduce the impact of pore water pressure on the stability of rock masses. However, these drainage measures are not applicable to all grottoes. Let us consider the prevention and treatment of seepage at Leshan Giant Buddha<sup>[155]</sup>, where conventional groundwater treatment measures have had poor effects. Treating water
